COLLISION REPAIR INFORMATION

TITLE: AVAILABILITY OF A REINFORCEMENT PLATE BETWEEN THE INNER FRONT FENDER APRON AND THE OUTER LOWER DASH PANEL PAGE 1 of 1

SECTION: STRUCTURAL REPAIR BULLETIN #13
MODELS: RN SERIES
DATE: AUGUST 1986

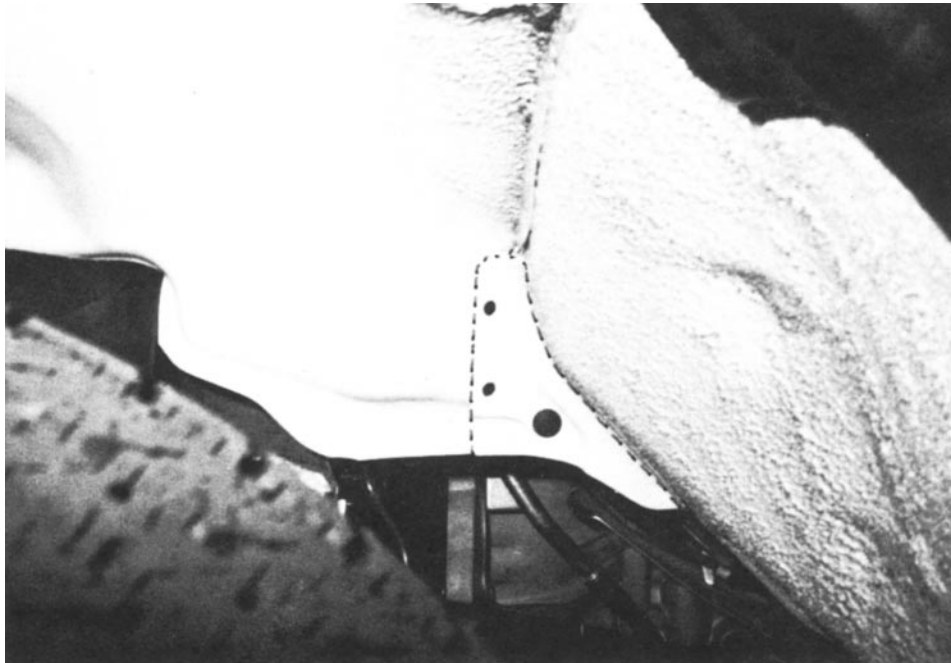
As part of Toyota's continuing effort to provide collision repair shops with efficient, cost saving repairs, Toyota Motor Corporation has recently announced the availability of a replacement reinforcement plate (previously not available through Toyota Parts) that connects the inner front fender apron to the outer lower dash panel. This part is a direct replacement part for the original equipment part that is attached to the body during factory assembly (see photo below).
