COLLISION REPAIR INFORMATION

TITLE: PINCHWELD UNIBODY
CLAMP INSTALLATION

SECTION: STRUCTURAL REPAIR BULLETIN #57

DATE: MARCH 1994

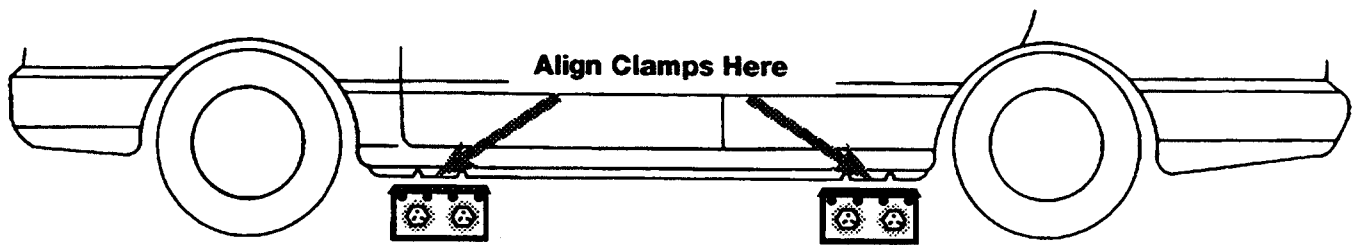
Illustration C.

Toyota recommends the unibody mounting locations shown in illustration C.

NOTE: Installation of four unibody repair clamps is recommended.

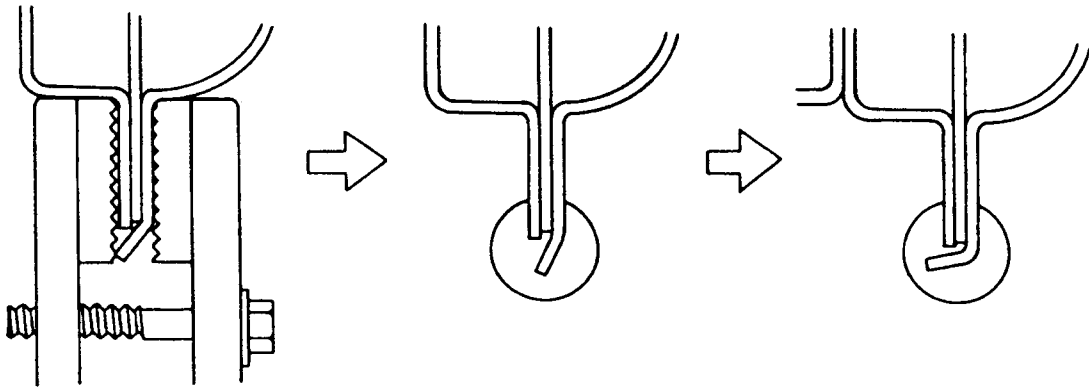
Illustration E.

The pinchweld will be deformed from the installation of clamps, giving the appearance of a wavy rocker panel. Therefore, the pinchweld must be restored to its original shape. See illustration E.

The rocker panel must be refinished at the attachment site area after repairing the body. Included in refinishing is:

- outer rocker panel
- inner rocker panel

Reapply PVC undercoating to the floor pan as necessary. This area must have rust and corrosion protective materials applied comparable to OEM. Undercoats that are environmentally friendly (low VOC) with maximum corrosion protection, and adhesion are encouraged. Follow manufacturers recommendations for application procedures and necessary equipment.
