COLLISION REPAIR INFORMATION

TITLE: QUARTER PANEL SECTIONING
(CUT-P) PROCEDURE

SECTION: EXTERIOR BULLETIN #85

MODELS: ALL TOYOTA /LEXUS

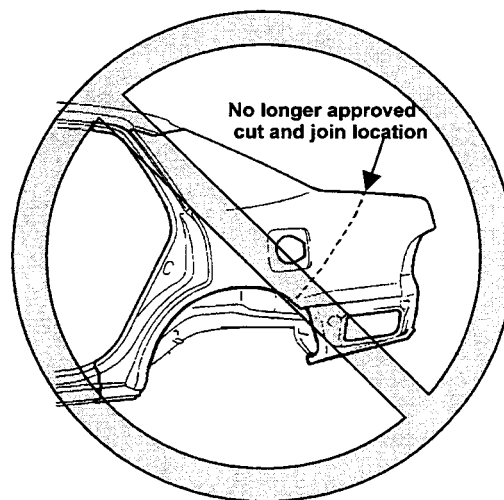
The Quarter Panel Sectioning (CUT-P) procedure, as shown in Toyota and Lexus Body Collision Damage Repair Manuals, and sometimes referred to as “vertical cut” is **no longer an approved** repair procedure (when replacing a damaged quarter panel) of any Toyota or Lexus vehicle. (see illustration below)

Research indicates this procedure may not satisfy customer expectations in terms of visible repair quality. This repair is viewed primarily as a potential cost-savings process.

Toyota no longer approves of this CUT-P procedure for some of the following reasons:

- Visible cut and join locations from inner trunk compartment
- Body character lines are difficult to weld across
- Very difficult to perform an undetectable repair
- Customers overall cost of ownership is not reduced
