# COLLISION REPAIR INFORMATION

TITLE: QUARTER PANEL SERVICE PART MODIFICATION

SECTION: EXTERIOR BULLETIN #162

MODELS: TOYOTA & LEXUS AS LISTED

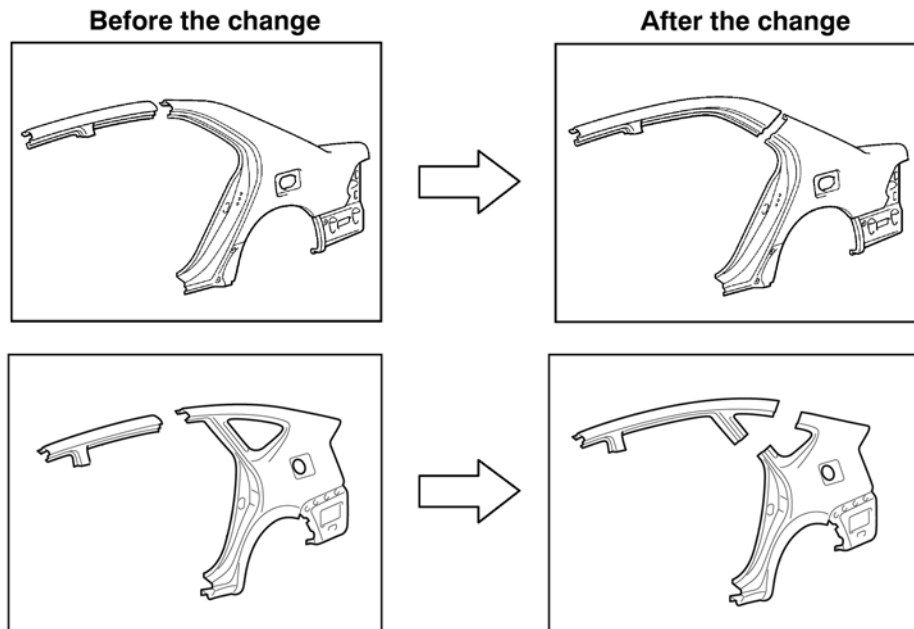
To improve storage and distribution logistics and reduce waste material, a change to Quarter Panel service part cuts have been made on select models. Implementation timing will vary due to number of in-stock units. Superseding part numbers will be issued as new stock arrives. The revised panel cuts are 50 mm in the roof direction from the specified cut-and-join location listed in Collision Damage Repair Manuals available from the Technical Information System (TIS) at ([www.techinfo.toyota.com](http://www.techinfo.toyota.com)). This revision does not represent any change to replacement specifications. Please refer to the illustrations and model-specific references below.
