COLLISION REPAIR INFORMATION

TITLE: FENDER BRACKET REPLACEMENT

SECTION: ELECTRICAL BULLETIN #184

MODELS: 2012- TOYOTA CAMRY/CAMRY HV and 2013- LEXUS ES350/ES300H

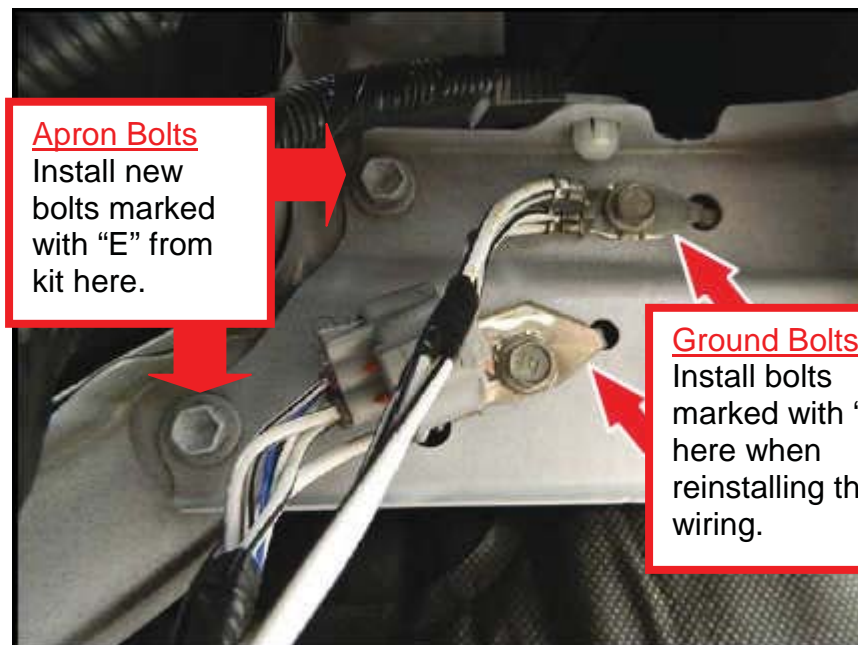
Model Year 2012- Camry/Camry HV and 2013- ES350/ES300H use the left front fender mounting bracket (Toyota PN 53804-33030 Lexus PN 53804-33040) as a ground location for an Integration Relay and the Engine Control Module. If this bracket is damaged and replaced, or repaired and reused, it is critical to follow the procedures and precautions provided below when removing or installing the bracket and ground wiring:

Apron Bolts

Ground Bolts

Install new bolts marked with "E" from kit here.

Install bolts marked with "E" here when reinstalling the wiring.

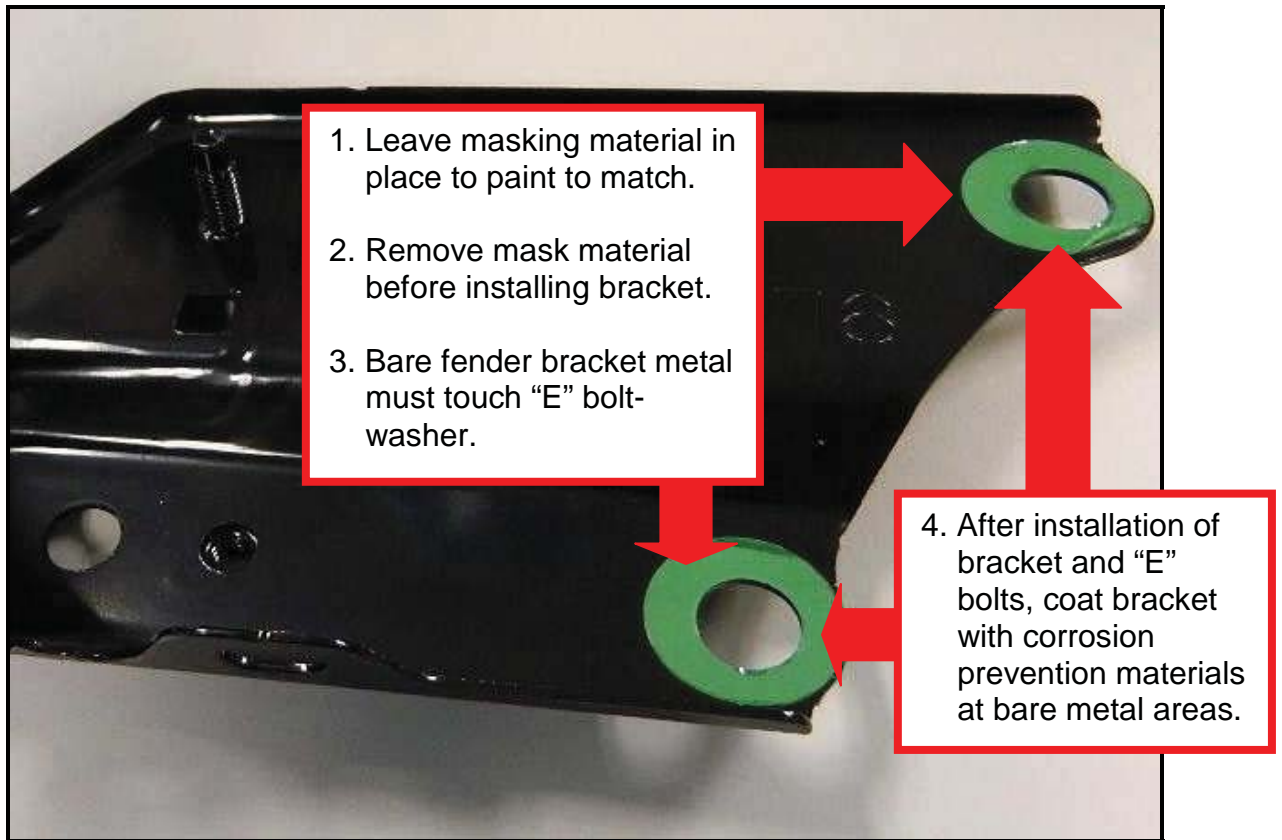
- Genuine OE replacement bracket kits are supplied with instructions, special attachment bolts and washers, as well as masking material at attachment bolt contact locations.

- Read and follow the new bracket installation instructions supplied in the kit.
- Do not remove the masking material on the new bracket before painting.

- Before installing the bracket remove masking material at apron attachment points.
- Use the new bolts supplied in the kit with the "E" marking on the bolt head. These bolts will cut thru paint and oxidation at the bolt threads to help ensure a good ground.

- Install bracket and ground wiring, and torque Ground bolts to 6.9-9.8 N*m (5.1 – 7.2 ft*lb) 70-100 kgf*cm, and Apron bolts to 3.9 – 8.8 N*m, (2.8 - 6.5 ft*lb,) 40-90 kgf*cm.

- Reattach negative battery terminal and check that ground wiring voltage drop is less than 0.2 volts.
- To prevent corrosion from developing at the bracket apron bolt hole area, neatly apply a heavy coat of a corrosion prevention material such as 3M™ Rust Fighter-I Part Number 08892 or equivalent around the area of the apron bolts.
