COLLISION REPAIR INFORMATION

TITLE: CELICA DOOR MIRROR REPLACEMENT

SECTION: EXTERIOR BULLETIN #12

MODELS: 1986 TOYOTA CELICA

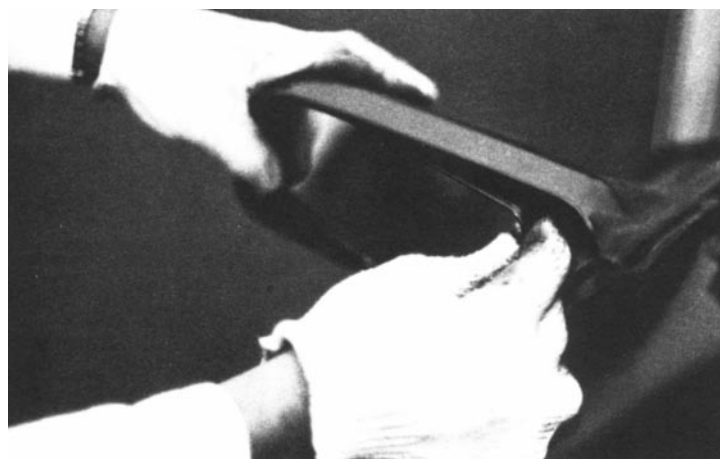
1. Remove loose glass fragments if present from mirror to prevent personal injury.
2. Lower the side door window.
3. Use a heavy cotton glove, firmly grasp the mirror frame as shown and pull straight out. (Note: If mirror has heating element, carefully disconnect wire connector.)

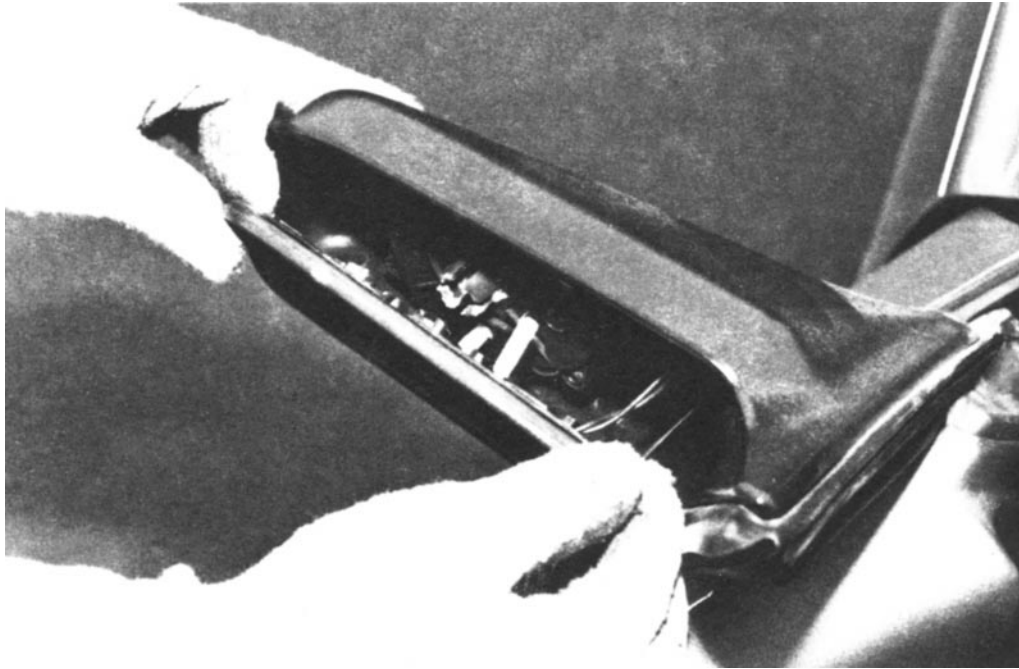
4. Align the new mirror and frame with the housing. Note the position of the two white threaded plastic studs and the pivot ball and socket. Be sure to connect the mirror heating element connector if so equipped.

NOTE: If the replacement mirror water drain hole is smaller than 5mm, use a sharp pointed knife to enlarge the water drain hole size to 5mm in diameter, as shown below.

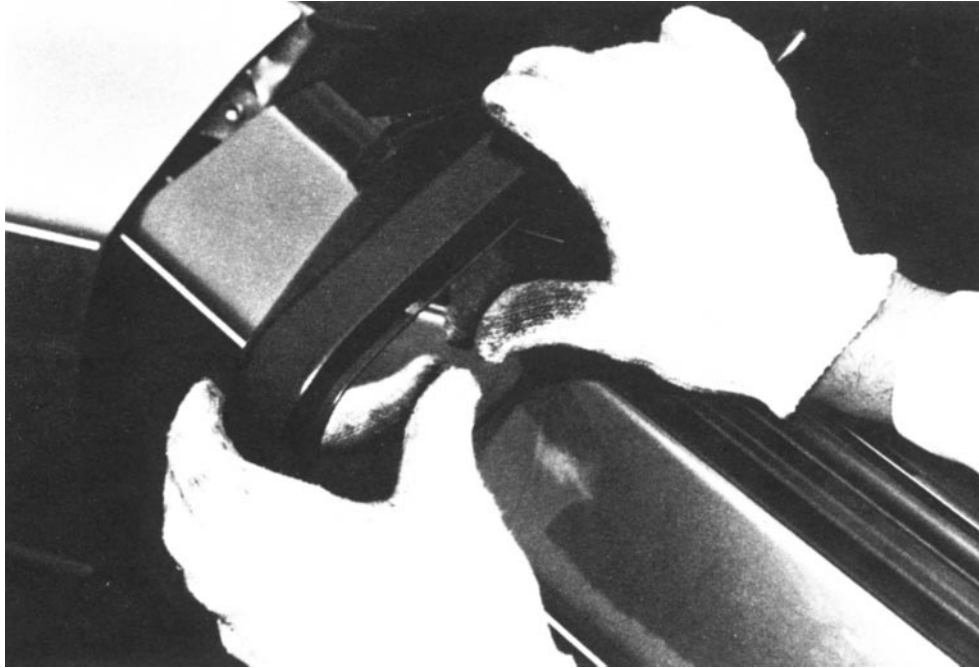
5. Press firmly on the mirror over the center portion until the ball snaps into the socket.
