# **COLLISION REPAIR INFORMATION**

TITLE: TACOMA SMC BED REPAIR

SECTION: EXTERIOR BULLETIN #168

MODELS: TACOMA 2005 -

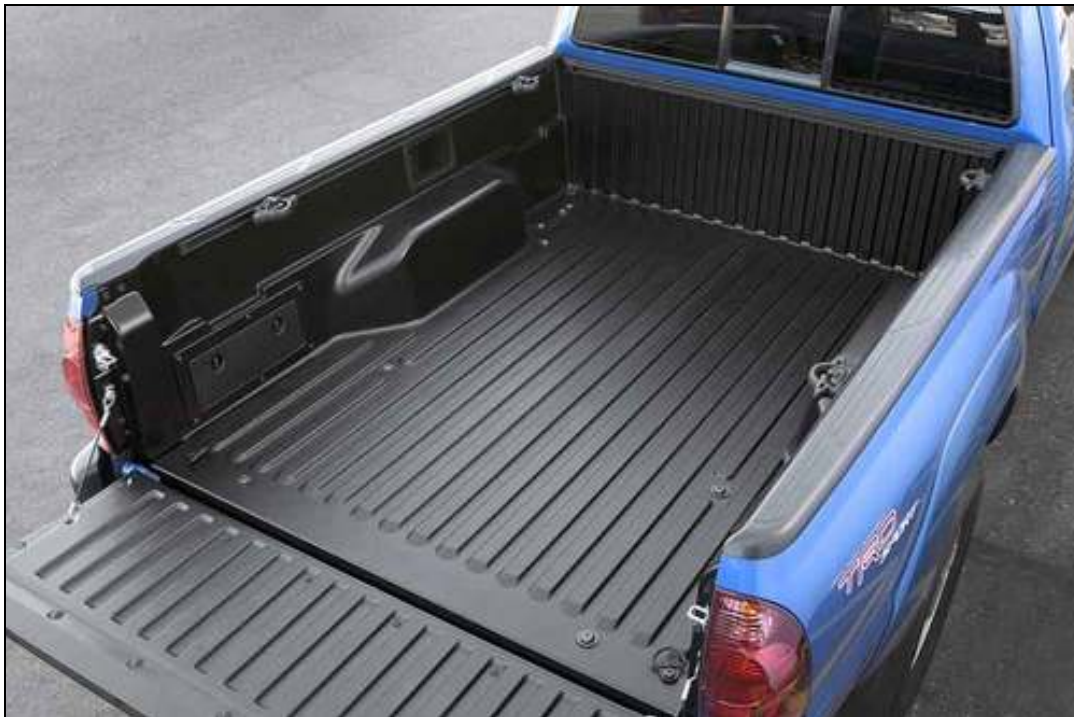
(EXAMPLE OF TACOMA SMC PICK-UP BED)

Beginning with the 2005 Model Year, the Tacoma has been equipped with a Sheet Molded Compound (SMC) pick-up bed tub. The SMC bed offers rugged performance and utility attributes but, like all body components can sustain damage as a result of a collision. While materials are available to repair SMC, they typically require reinforcing, sanding, priming, and top-coating. SMC repairs of this type will lack the original Tacoma quality and appearance, and may not function as intended under future operating conditions and subsequent collisions. Therefore it is recommended to replace collision damaged SMC beds with genuine new original equipment replacement parts only.
