COLLISION REPAIR INFORMATION

TITLE: HSS & UHSS CABIN REINFORCEMENT REPAIR & REPLACEMENT
SECTION: STRUCTURAL BULLETIN #175 (revised)
MODELS: ALL TOYOTA, LEXUS, and SCION
DATE: DECEMBER 2009

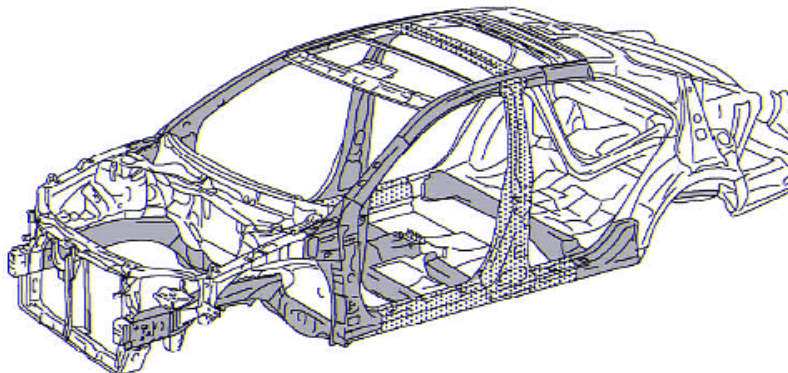
- Example Structural Outline -

Model-specific 'Collision Damage Repair Manuals' contain 'Structural Outline' illustrations that identify locations and strength ratings for High Strength Steel (HSS) and Ultra High Strength Steel (UHSS) components throughout body and frame structures. This information is provided so that collision repair professionals can make informed decisions on repair and replacement of components that provide high margins of crash safety to vehicle occupants.

- Hot and cold straightening methods
- Sectioning of 980 MPa and 590 MPa strength-rated pillar reinforcements
- Sectioning of 440 MPa rated components at locations other than those specified
