COLLISION REPAIR INFORMATION

TITLE: CAMRY BUMPER DISCOLORATION
SECTION: REFINISH BULLETIN #171
MODELS: CAMRY AS LISTED
DATE: FEBRUARY 2009

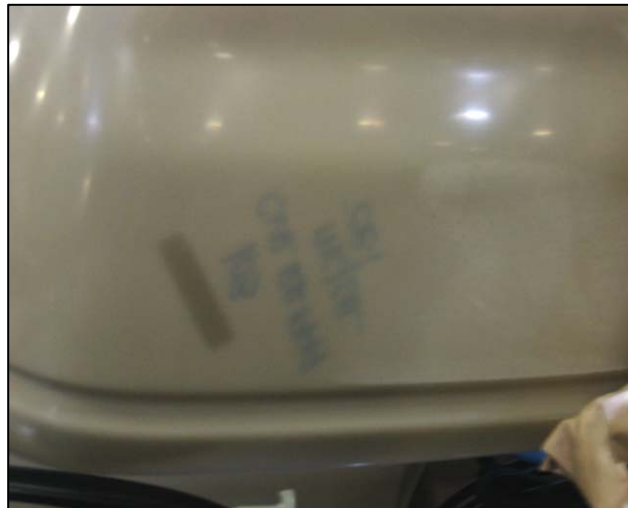
The listed Camry OE service parts may exhibit a color difference in the form of visible marking of the exterior surface similar to the bumper in the photo provided below. While the markings are visible from the outer surface, there have been no issues effecting refinish operations, paint adhesion, or bleed-through reported or discovered during refinish validation tests. Toyota strongly recommends following preparation and refinishing procedures outlined in Collision Repair Information Bulletin (CRIB) #170.
