2014 MDX: New Model Body Repair Information

OVERVIEW OF BODY FEATURES

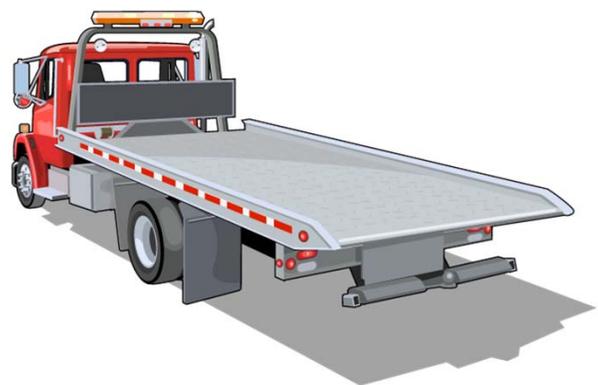
LIFTING AND TOWING PRECAUTIONS

- SH-AWD models must be towed using flat bed towing equipment only, or transmission damage may result.
- 2WD models may be towed using front wheel lift or flat bed towing equipment.
- Models equipped with the SH-AWD system do not have a manual switch to disable the system. Whenever service work requires spinning the front or rear wheels with the engine, always lift and support the vehicle so all four wheels are off the ground.
- Do not lift or tow this vehicle by its bumpers, or serious damage will result.
- For more information, refer to "Lift and Support Points" in the appropriate service or body repair manual.

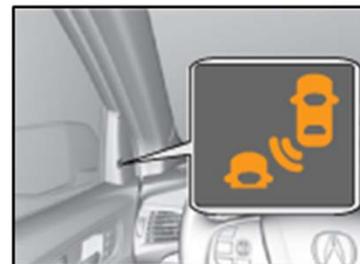
Left Rear of Vehicle Behind Bumper

Models equipped with this system can be identified by this BSI Alert Indicator, located on both front doors near the outside rearview mirror.

- The system uses two radar units mounted on each side of the vehicle under the rear bumper.
- The system may malfunction and set DTCs because of damage, improper repairs, or excessive foreign material on any of the following:
 - Rear bumper
 - Outer side panels
 - Radar unit mounting locations
- Several checks and inspections must be done during repairs to the radar unit mounting area. Procedures to check the BSI radar unit mounting area can be found:
 - Body repair manual “Rear Side Outer Panel Installation”
 - Service Manual “BSI radar unit mounting area check.”
- If the mounting area check is not done, an Acura dealer may not be able to properly aim the radar units.

- After replacing or removal and installation of one or both BSI radar units.
- After replacing/repairing the body rear outer side panel(s).
- Stored DTCs B18B8 or B1E68 - Left or right side BSI radar unit azimuth off alignment.

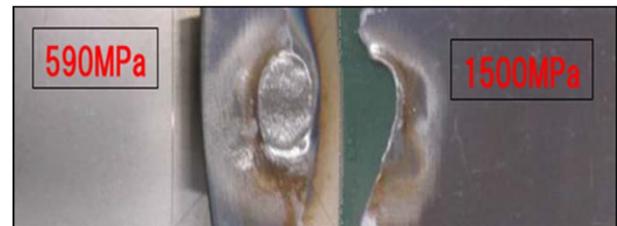
Tensile Test Results of Welded 1,500 MPa Steel

- NEVER perform MAG welding on 1,500 MPa steel. The heat generated during welding will significantly reduce the strength and structural integrity of 1,500 MPa steel parts.
- This photo shows tensile strength test results of welded 1,500 MPa steel. The 1,500 MPa steel fractured first, because the welding heat reduced its strength far below 590 MPa.
- For more information, refer to “Hot Stamp (1,500 MPa) Parts Welding Specifications” in the body repair manual.

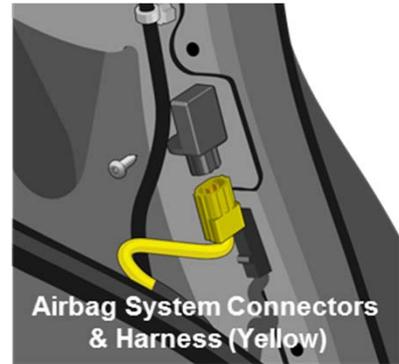
AIRBAG SYSTEM ELECTRICAL REPAIRS

- For easier identification, electrical connectors that contain only airbag system wiring are yellow in color.
- Many harnesses that contain primarily airbag wiring are also wrapped in yellow tape.
- Airbag system wiring that runs in a common harness, such as a floor harness, is generally not marked.
- NEVER attempt to modify, splice, or repair airbag system wiring. If airbag system wiring is damaged, replace the wiring harness(es).

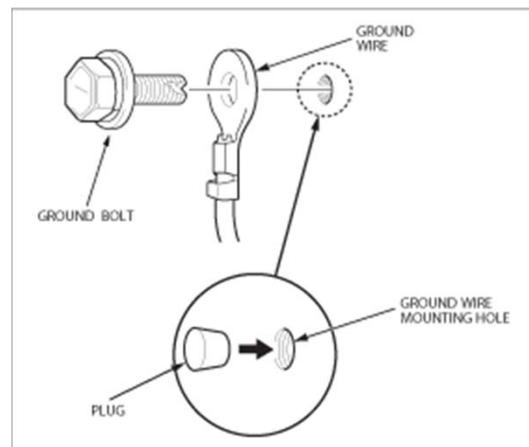
ELECTRICAL GROUND WIRE PROTECTION

- Painting over electrical ground locations may cause electrical systems, such as Vehicle Stability Assist (VSA), to malfunction and set DTCs that may be difficult to diagnose.
- Protect the ground wire and the ground wire mounting hole threads with a bolt or plug when priming or painting.
